Archaeological and Biological Examination of The Bronze Pin Wreck (8MO1879) off Grassy Key, Monroe County, Florida: an Interim Report

A Report by the Florida Underwater Archaeology Team,
Bureau of Archaeological Research, Division of Historical Resources,
Department of State

January 2009

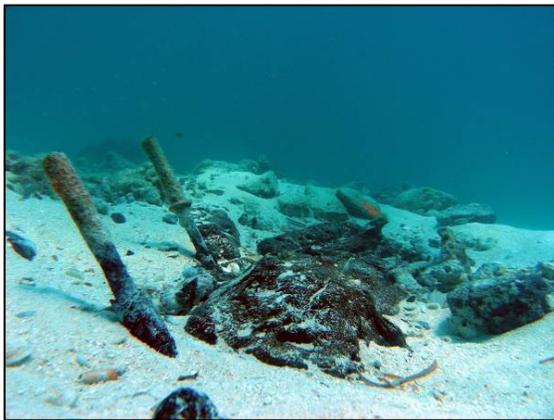
A series of copper-alloy bolts and iron bolts associated with remnants of wooden cant frames suggest that the southeast area of the site represents the bow. In the bow, along the port side, there are five wooden frames partially exposed. The forward three frames are clearly rising steeply. Additionally, the forward two frames are compass timbers, with the center grain of the tree still visible. These two frames do not have any space between them but are separated by an aggregate filling. Also in the bow is a thin, flat metal wedge between the ceiling planking and the frames. Additional features include a square nail hole, a tool mark in the frame near the square nail hole, and loose, disarticulated iron fasteners.

Figure 6. Image of fasteners and wooden frames looking from the bow towards the stern.

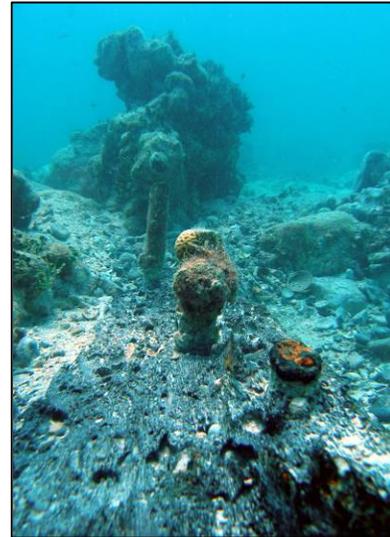
Figure 5. View looking from the stern towards the bow.

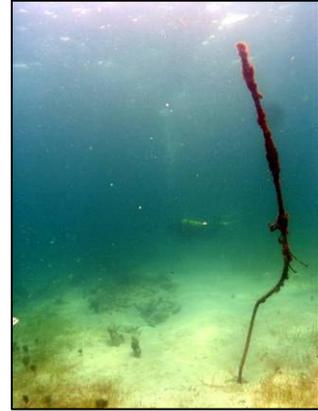
Also in the bow is a vertical, spire-like section of encrusted wire-ropes, 12 feet in height from the base of the scour pit up to 7 feet below the surface of the water. Based on its location this may be a portion of the standing rigging associated with the bowsprit such as a head stay or martingale. The martingale was a part of the standing rigging that strengthened the bowsprit and jib boom against the force of the head stays.

Figure 7. Standing rigging and view of bow.

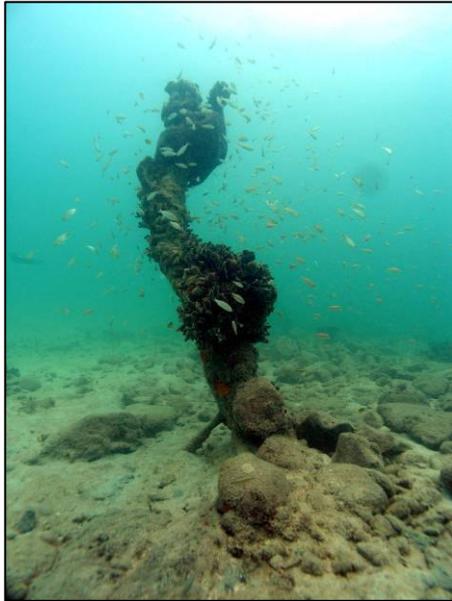
Figure 8. Starboard side frame.

There are the remains of twelve iron reinforcing frames: five frames on the port side, six on the starboard side, and a dislodged iron frame located on the edge of the sand pocket. The frames appear to have been inserted sometime after the ship was built and fastened to existing wooden frames and futtocks with heavy copper-alloy bolts. These frames extend from the floor up to the turn of the bilge to reinforce the ship below the waterline.

Spaced approximately 10 feet apart on both port and starboard, the frames average 3 inches in molded-height and between 4 and 6 inches in sided-thickness. All are heavily encrusted with hard and soft corals. Two of the frames have been displaced from their original position, one lying flat on the seabed, Frame 1, and the second being the dislodged frame lying approximately 28 feet away. Exposed

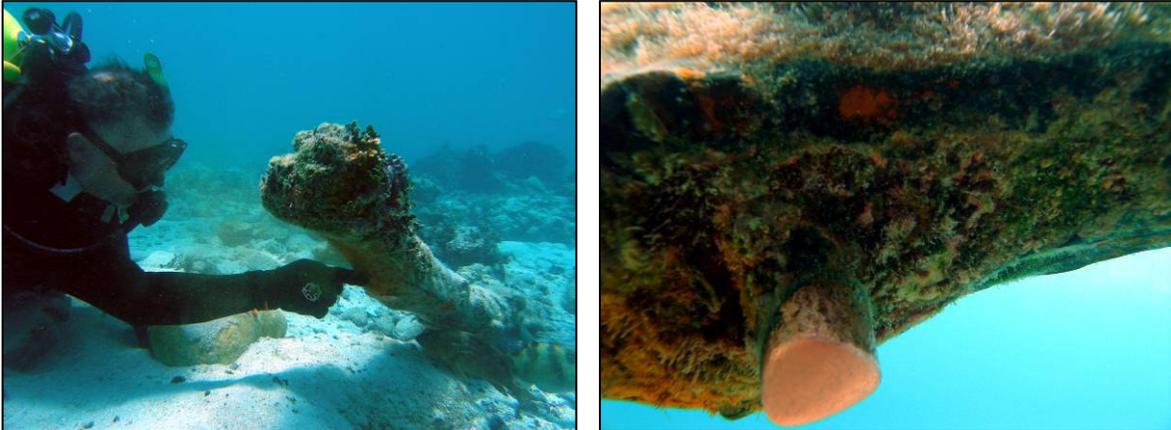
Frames 4 and 5 appear to be turtle scratching stations. Frame 4, which is located on the port side, is 78 inches in length, and has remnants of three copper-alloy fasteners spaced approximately 20 inches apart along its length. The underside of the frame has prominent, concave shapes worn into the iron as well as exposed, worn copper-alloy bolts, which show obvious signs of wear from sea turtles rubbing their dorsal carapaces against the structure to remove parasites. This activity has exposed wooden ceiling planks and frames below the iron frame and the copper-alloy pins associated with these timbers have also been worn down by turtles rubbing their plastron against the pins and

ballast stones. Frame 5, which is 72 inches in length, also shows extreme wear on its underside from turtle scratching activities.

Figure 9. (left) Port side frame showing evidence of turtle scratching. (right) Copper-alloy fastener rubbed down as a result of turtle scratching.

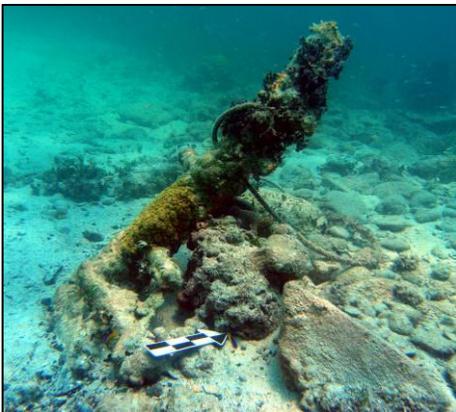
Figure 10. Iron reinforcing knee.

An iron reinforcing knee was noted on the starboard side between Frame 8 and Frames 6 and 7 (Frames 6 and 7 are part of the same broken frame). The iron reinforcing knee has similar sided and molded dimensions to the iron frames, 3 inches molded and 4 inches sided, and is also fastened with copper-alloy bolts.

This is the only knee located on site and appears to be a hanging knee that became displaced from the hull. No lodging knees were visible.

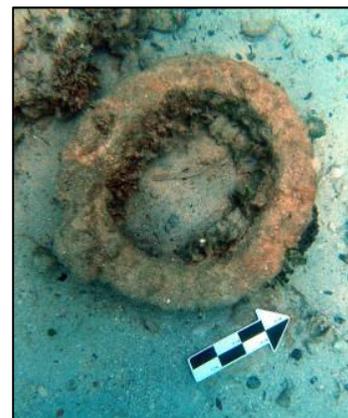
An oblong object, located midships, is believed to be an in-deck hawsepipe with the following dimensions: the outer diameter of the pipe is 1 foot, 4 ½ inches by 1 foot, 6 inches across and 7 inches deep. The hawsepipe only has one lip which is 3 inches in width and 1 inch in depth. Based on the location of the hawsepipe at midships, it may indicate that this was an internal-deck hawsepipe as opposed to a more commonly found gunnel hawsepipe located in the bow.

Figure 11. Hawsepipe.

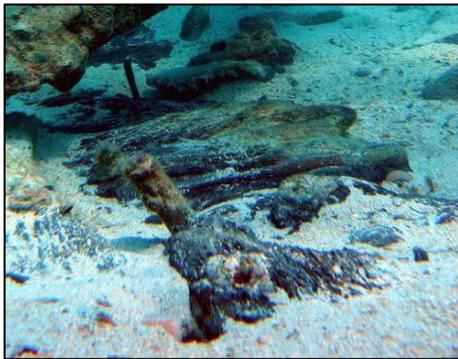
Figure 12. Frames under Frame 4, along port side.

The floor frames, where they can be measured, are consistently 10 inches in sided-thickness and 10 inches in molded-height. They tend to be tightly spaced throughout, with space ranging from no space to 2 inches. Floor frames are found in the bow along the port side, in the stern on the port side, and on both the port and starboard midships.

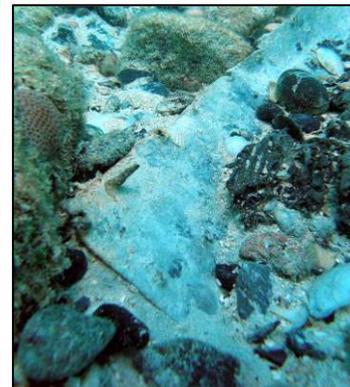
On the starboard side, between Frames 9 and 11, a run of copper-alloy sheathing was observed fastened to the hull planking. The sheathing was initially thought to be lead due to its grey color however, after careful examination it appears to be copper-alloy, and its placement and extent suggest that the entire ship may have been sheathed below the waterline as opposed to isolated patches.

Figure 13. Hull sheathing and sheathing tack.

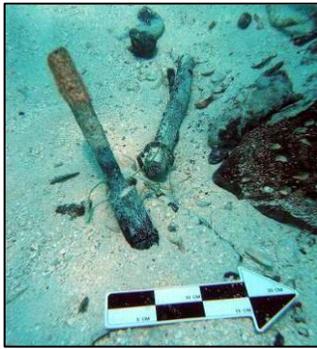
Figure 15. Copper-alloy pins located in the bow.

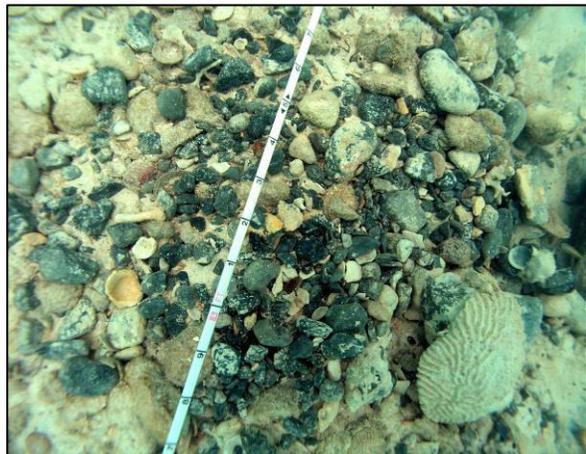
The ballast is distributed throughout the ship. Smaller ballast is found loosely across the site as well as larger stones which are found in concentrated clumps around areas that have iron fasteners. There are also large cut ballast stones, but nothing larger than one person can handle.

Ballast forward of midships appears to have been moved from the centerline to either side. This could be a result of modern day salvage activity. There is also a large scatter of ballast throughout the seagrass along the aft port side of the site. It is generally fist-sized ballast which may have been dispersed during a storm surge. The amount of ballast in the ship reinforces the notion that it was a sailing ship.

Figure 16. Sample of ballast from midships.
