ARCHAEOLOGICAL STABILIZATION GUIDE

CASE STUDIES IN PROTECTING ARCHAEOLOGICAL SITES

ARCHAEOLOGICAL STABILIZATION GUIDE: *Case Studies in Stabilizing Archaeological Sites*

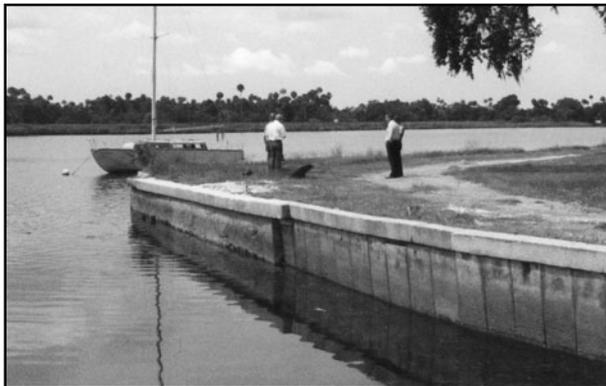
To the left is the seawall protecting the back face of Crystal River mound. A seawall is a structure separating land and water areas primarily to prevent erosion and other damage caused by wave action.

Construction of an access stairway over the eroding pedestrian access trail; and (2) repair of the collapsed seawall including removal of the fallen portion, recovery of eroded cultural deposits (some of which were layered on the submerged seawall, while intact remains were discovered in the river bottom), the installation of steel support rods, and the excavation and backfill of the area where support rods were placed. The archaeological deposits are protected by the seawall.

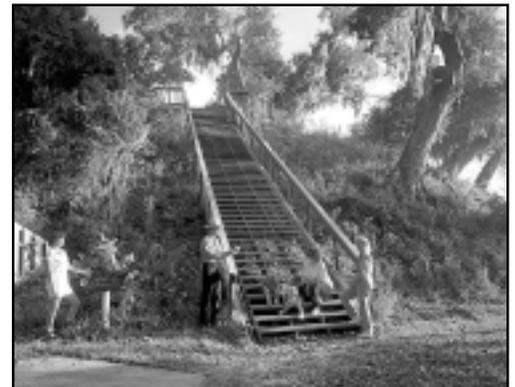
Above: Mound with access ramp, Crystal River State Archaeological Site.

Outcome: (1) The stairway has stabilized the erosion problem on the mound and enhanced visitor access to it; and (2) seawall replacement revealed intact cultural remains and much less site disturbance than expected in the seawall area. The new seawall will serve to protect these remains and future researchers and site managers will know to consider the sensitive nature of this shoreline site area before initiating any resource management effort. A fence was installed along the river side of Temple Mound "A" to stop visitors from walking up the side of the mound. Additionally, a large tree that was located on the top of the mound was cut off at ground level to prevent the tree from falling down in a storm and the root system destroying part of the mound.

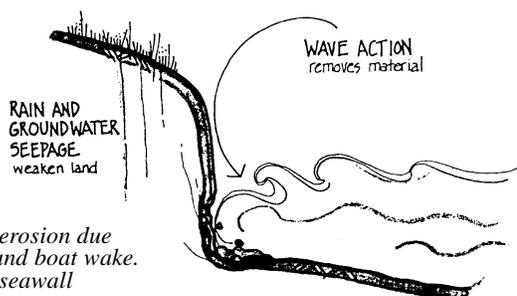
Left: Diagram of erosion due to currents and boat wake.
Right: Diagram of seawall

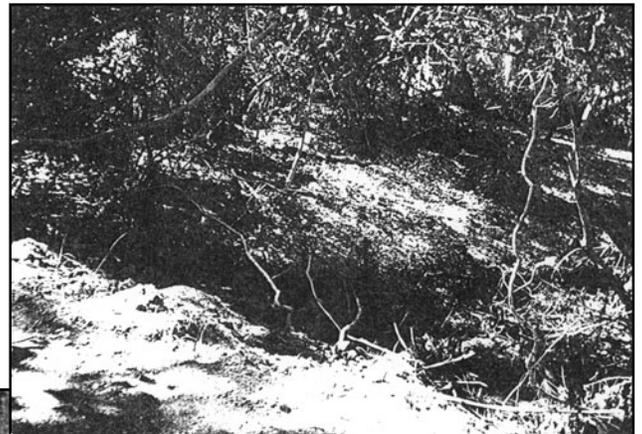
Shell midden showing damage due to foot traffic.

Management Problems: Shoreline erosion is damaging the Manatee River side of the Portavant Mound, and looting has occurred in erosion-exposed areas. Exotic vegetation and foot traffic have destabilized the site, particularly the mound areas.

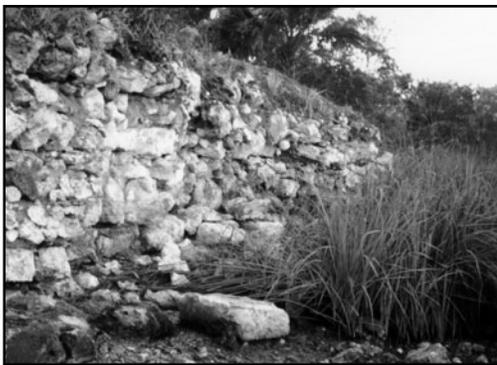
Shoreline erosion of fort wall, Fort San Marcos de Apalache, before construction of a protective bulkhead.

earlier barrel well. Along the Wakulla River side, a cut limestone fort wall has for years been eroding and collapsing, thereby threatening the integrity of the site protected by the wall.

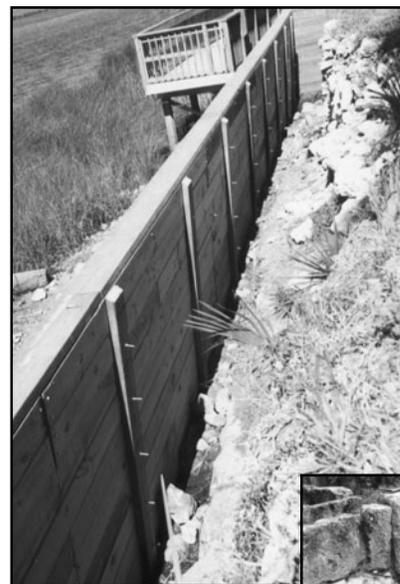
These photos show fort wall bulkhead construction during different phases.

Management Solutions: In addition to resource documentation, protective measures need to be planned and implemented along the St. Marks River. A bulkhead was constructed as a temporary measure for one portion of the cut stone fort wall along the Wakulla River shoreline.

Outcome: Along the Wakulla River, settling and washout of sand backfill behind the bulkhead are creating indentations on the surface, requiring routine filling. Sand is slowly being lost from the revetment, and it shows signs of movement, suggesting the need for structural design modifications.

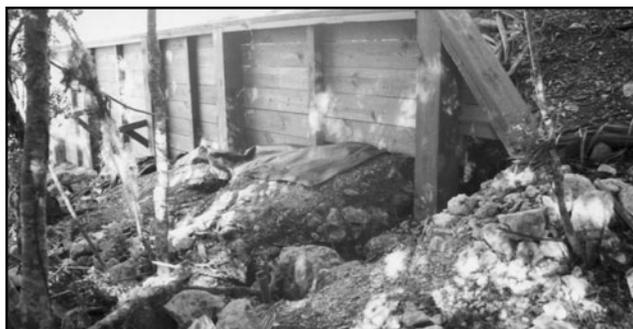
A bulkhead is a structure that retains or prevents land from sliding into the water or protects it from wave damage. It functions much like a seawall (see Crystal River case study for seawall illustrations).

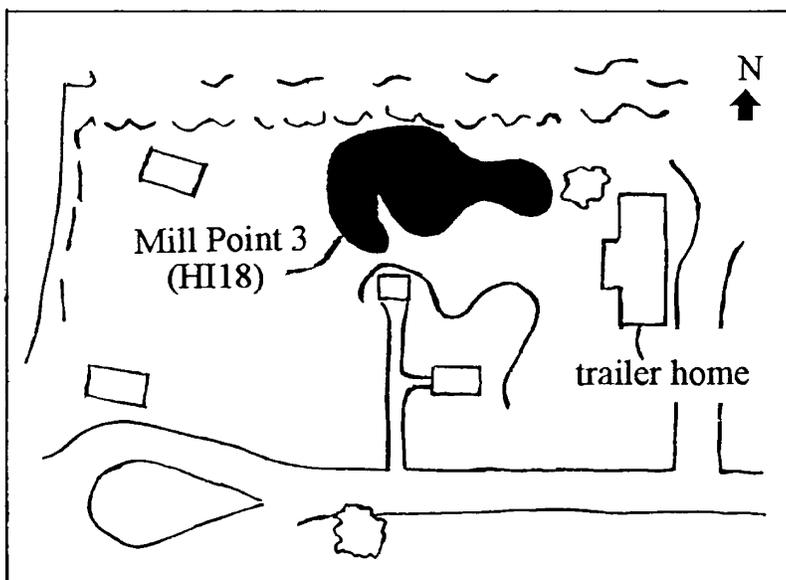
Location of shell mound in relation to trailer home and septic tank.

Management Solutions: Because the removal process was considered potentially damaging to the site, a scope of work was drafted with recommendations from Dr. Ryan Wheeler, Archaeology Supervisor in the Bureau of Archaeological Research. Dr. Wheeler visited the Mill Point site to assess the status of unmarked human burial remains. Recommendations were to dismantle and remove the trailer, and crush the septic tank and backfill it within a protective area, so as not to damage the mound. A safety fence with low impact posts would be erected to keep demolition activities inside the yard of the trailer. The work would also include removal of concrete pads, located next to the trailer, although leaving them in place could protect underlying site remains. A certified archaeological monitor was recommended to be present during the removal and stabilization processes, should any ground disturbing activities occur. Capping the site with a layer of organic soil and planting sod could help protect and stabilize the mound.

Outcome: On June 14, 1999, Kimmons Contracting Company removed the mobile home, pumped out and crushed the septic tank, and removed the orange safety fence surrounding the site. The concrete slab was left in place. Jill Lehman of Hillsborough County Parks and Recreation supervised the work. The area was mowed and grass allowed to spread to serve as a protective cover as well as to conceal the archaeological remains. The park plans to install posts around the perimeter of the area to keep out vehicles.

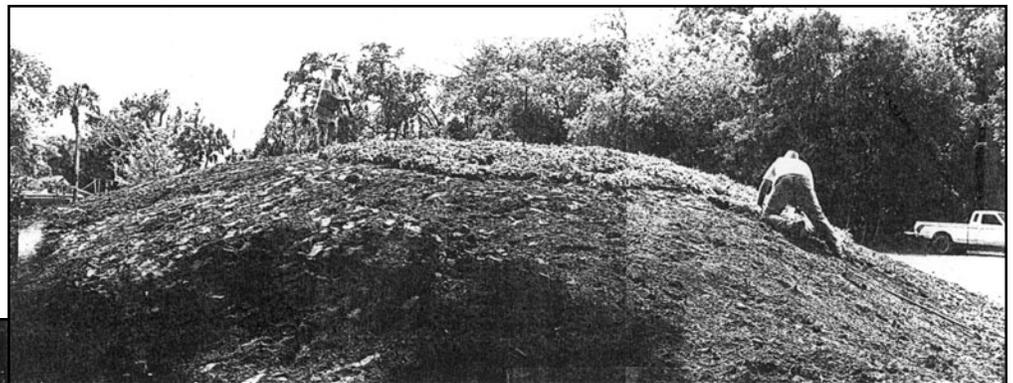
Above: Mound Avenue Mound being laid with sod.

Management Solutions: Limited archaeological excavation demonstrated to the private owners and the public that the mound contained undisturbed burials. The Town of Ormond Beach owned and managed shoreline portions of the adjacent village midden as a public park headquarters. The Volusia Anthropological Society (VAS) spearheaded a fund raising drive, which resulted in acquisition of the property and its conveyance to the Town of Ormond Beach for park purposes. The Bureau of Archaeological Research provided a staff archaeologist to work with Ormond Beach Parks Department and volunteers including VAS members, local residents, and Boy Scouts. They reburied previously excavated human remains in the area from which they had been removed, and spread a protective covering over the mound surface to restore its original appearance. Additionally, they installed irrigation pipe within the recent organic soil cap and layered squares of flower sod to protect the mound surface from erosion.

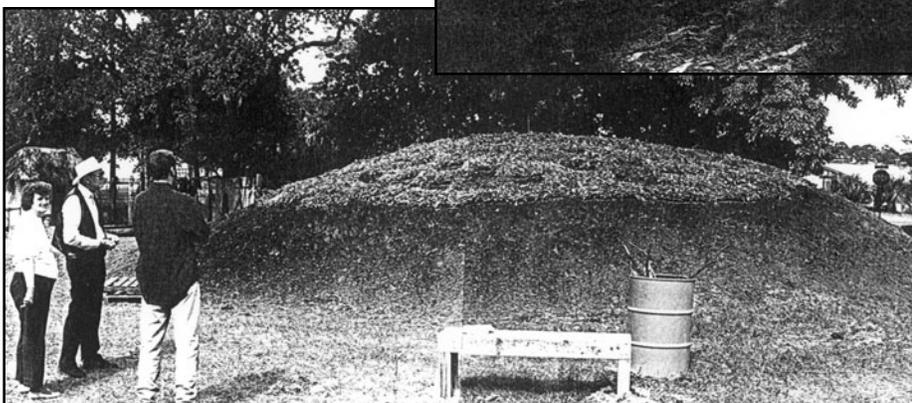
Left: Mound Avenue Mound after the revegetation process was completed. Volunteers admire their work after revegetating the mound.

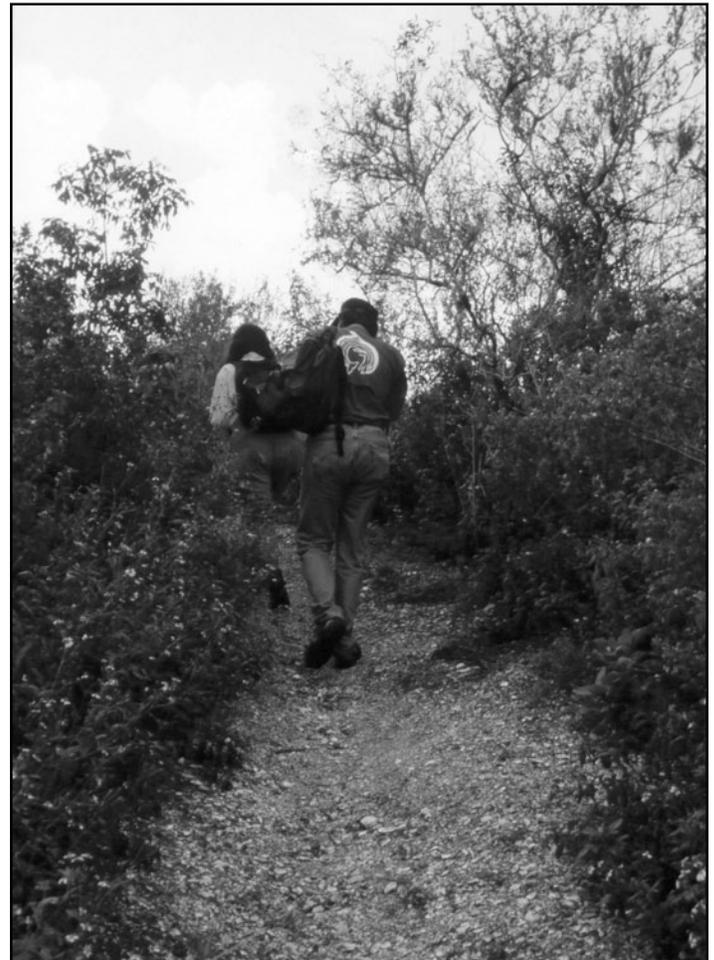
Trail across Mound 1, Mound Key.

Prior to placing the stairway, the trail furrow (which is a historic trail) would be filled using a combination of sandbags and other fill material. This method has been used before by the Florida Division of Recreation and Parks at the Crystal River State Archaeological Site and has been very successful. Sandbags, backfill, and additional fill material also are recommended to fill looter's holes. A detailed topographic map of the site, documenting looting areas, has been prepared to use in planning restoration activities and site interpretation.

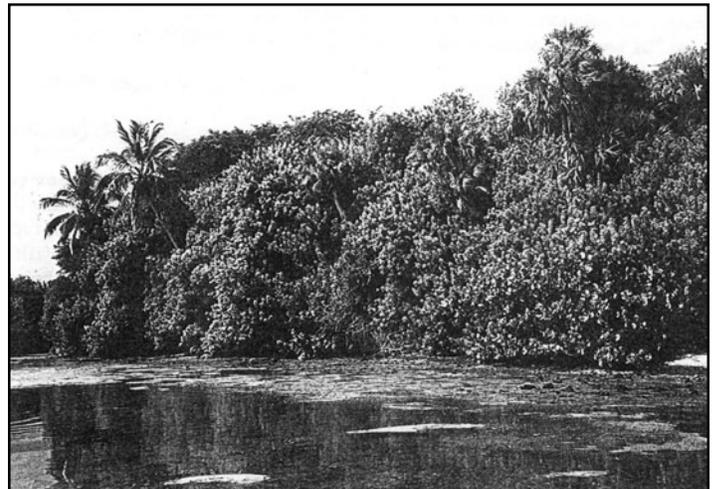
East side of Mt. Elizabeth showing erosion of mound into the Indian River Lagoon. Note the exotic Brazilian peppers covering the mound.

Management Problems: The site has sustained substantial damage, particularly due to vandalism, since it was first cleared in the late 19th century. The Indian River side of the site is eroding as a consequence of wave and storm action along the Intracoastal Waterway. Mount Elizabeth is particularly susceptible to damage caused by tropical storms and hurricanes, in addition to northeasters and periods of unusually severe weather patterns associated with El Niño.

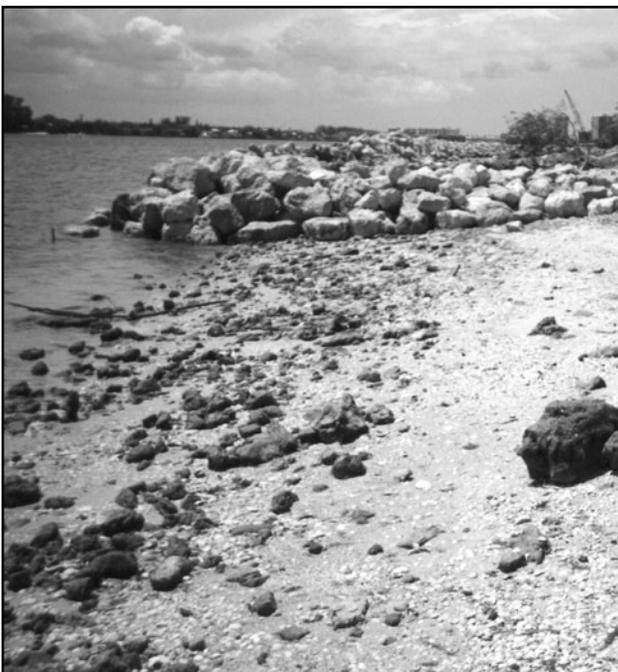
Historic seawall and dock area at Munyon Island.

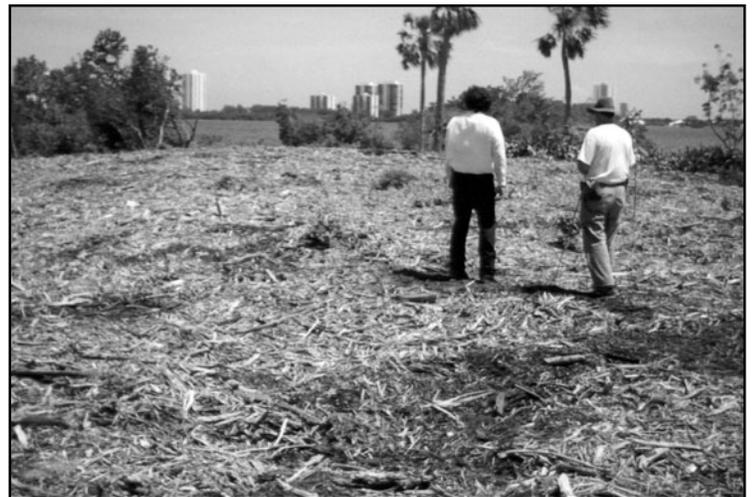
Mulched area showing plant holes from vegetation effort, Munyon Island Site.

Management Solutions: As part of an island restoration project in 1996, exotic plants and trees were removed by basal bark herbicide treatment, and manual and mechanized methods. Herbicide and manual methods were employed in areas with historic architectural remains to avoid or minimize damage. To prevent erosion and restore the natural environmental setting, exposed areas of the historic island ground surface were covered with wood chips, creating a rich organic topsoil. Selected native vegetation was also planted in areas that would not disturb archaeological and historical sites. To counter shoreline erosion, riprap (rock placed on a streambank to prevent erosion) was placed along selected areas subject to wave action. The earthen causeway to the island was breached to restore tidal circulation and eliminate vehicular access.

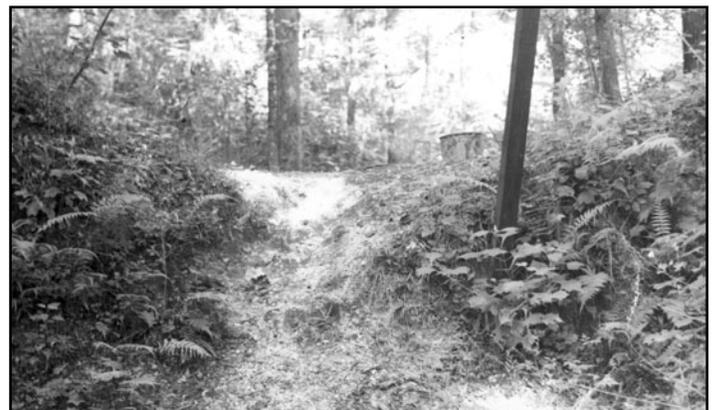
Damage from pedestrian traffic at the Nocoroco/Mount Oswald site.

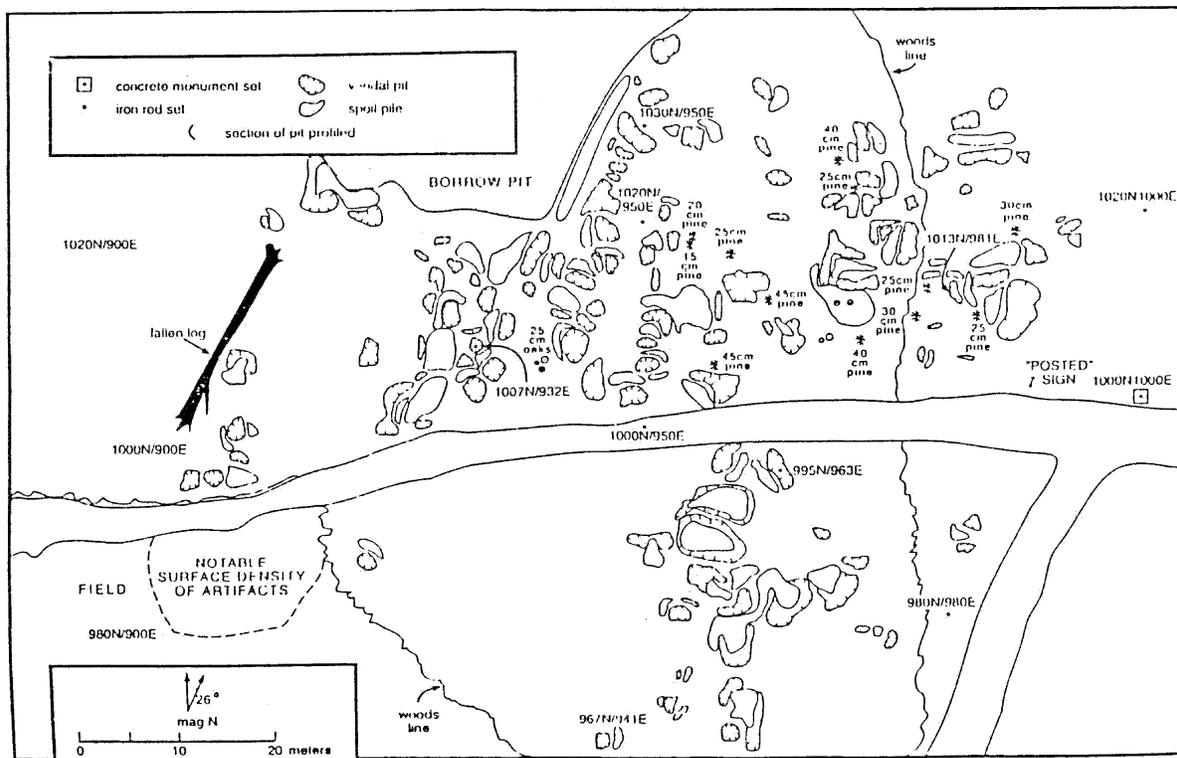
Location of vandal pits at 8SU121, Peacock Springs Recreation Area. Diagram taken from C.A.R.L. Archaeological Survey Report.

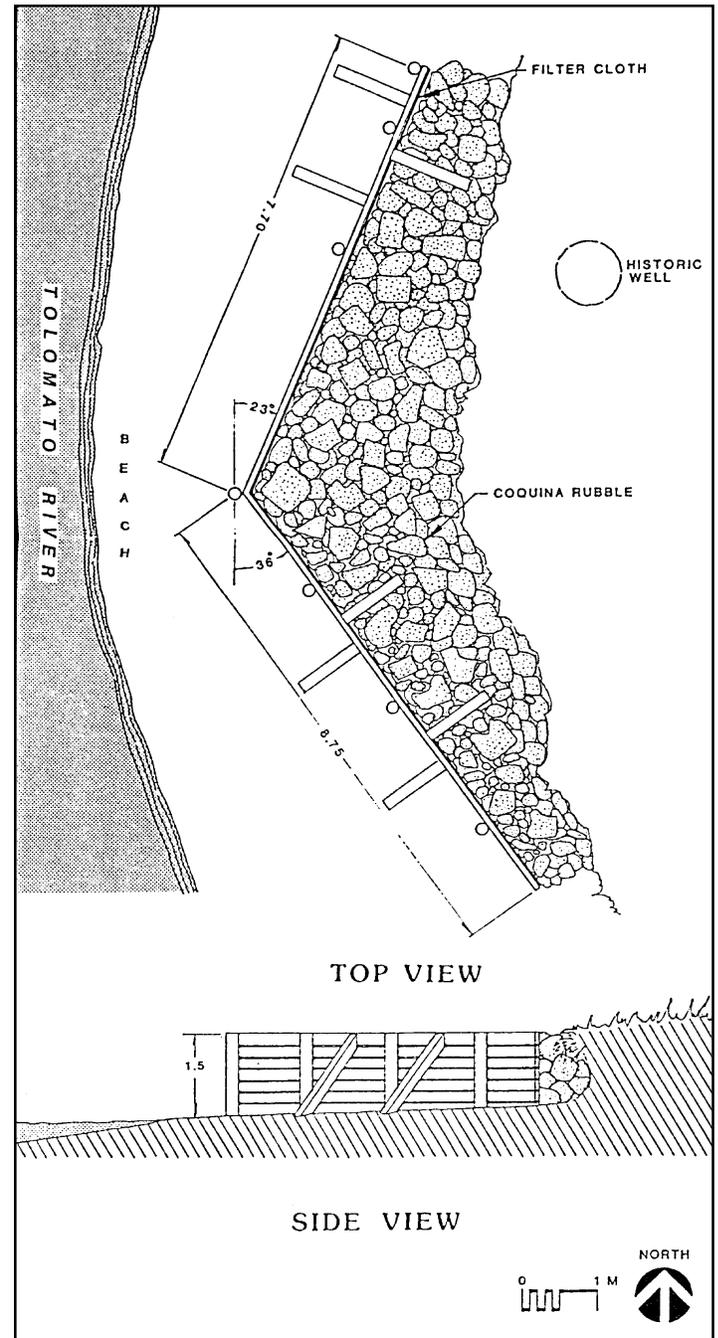
Plan of protective bulkhead. Diagram from U.S. Army Corps of Engineers Waterways Experiment Station 1990.

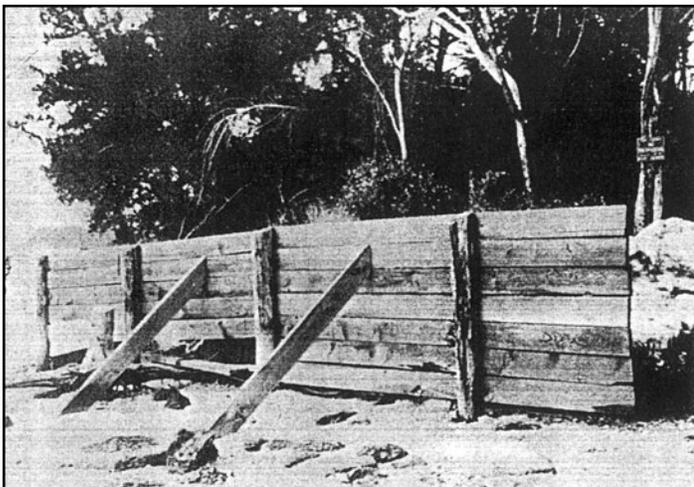
Storm-damaged bulkhead.

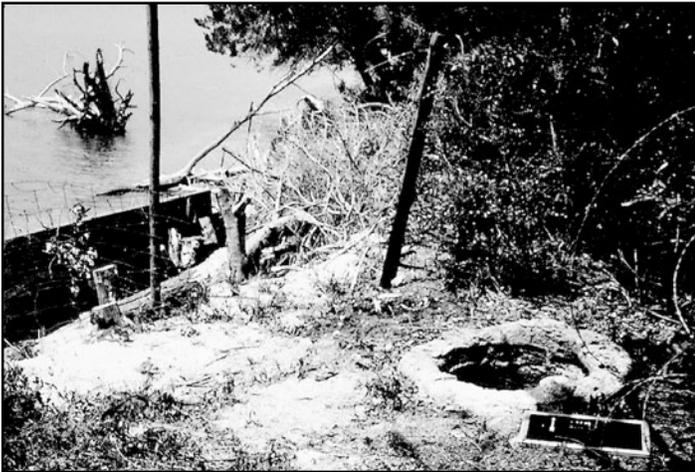
Riprap, or layers of stone placed along a shoreline to prevent erosion, and geo-webbing create a revetment for the Shell Bluff site.

A revetment is a structure placed on a bank to absorb the impact of incoming waves.

monitoring project, in which the rate of erosion across the western face of the site was measured. In 1992, the DEP placed riprap and geo-webbing along the shoreline. To stabilize the shoreline, park staff are utilizing boulder riprap, which is occasionally renewed.

Outcome: Replenishment of the boulders will be an ongoing activity because of the relatively high energy coastline of the Tolomato River. How often this will have to be done will depend on natural forces and also on boat traffic along the river.

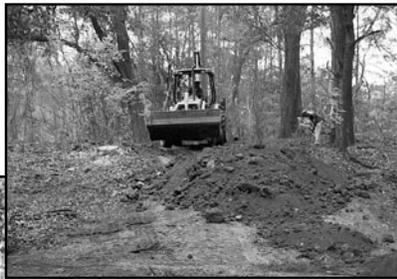
The equipment (right) is filling in the trench to stabilize the mound. The mulch trail was laid across the filled portion of the mound to permit visitor access.

Outcome: In 1982 developers donated a 1.91-acre parcel containing the mound to the State for preservation. In 1999 the Bureau of Archaeological Research filled in the trench and began work to establish the Velda Mound Park within the 1.91-acre lot. P.A.S.T. volunteers helped clear the site of trash and debris. A mulch trail was added around the mound and over the top of the mound, directly above the filled-in trench. Picnic tables were installed, along with signs to direct visitors to stay on the path, to identify the park, and to interpret the site. P.A.S.T. and Arbor Hill Neighborhood Association have agreed to monitor the site for vandalism and looting activities, and will contact the Bureau should these activities take place. The establishment of a park and site monitors have increased local awareness of the significance of the mound and greatly decreased the chances of future looting and vandalism to the site.

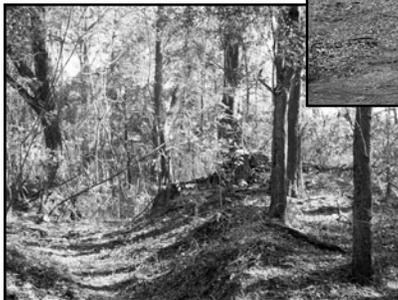
The photograph above shows damage to Velda Mound before it was restored to its current appearance. The trench (left portion of photo), cut through it by a bulldozer, was dug to recover artifacts, destroying a sizeable area along with information about the prehistoric occupation of the site.

Management Problems: During the 1950s, while the property was a part of the dairy, someone bulldozed a trench across the mound. Later, pot hunters are reported to have excavated a large hole near the center of the mound. In 1973, the Velda Dairy property began to be developed into a housing complex known as Arbor Hill. Over the next decade, three developers sequentially owned the property. More recently, the site became an unauthorized trash dump.

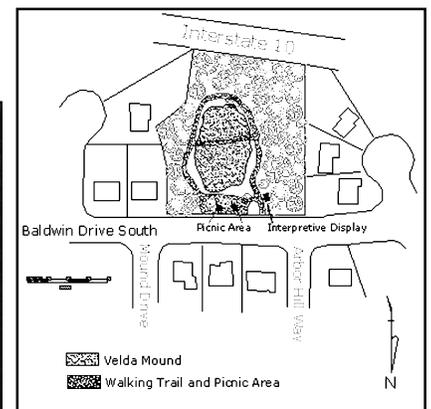
Map with mulch trail.
