Archaeological and Biological Examination of The Bronze Pin Wreck (8MO1879) off Grassy Key, Monroe County, Florida: an Interim Report

A Report by the Florida Underwater Archaeology Team,
Bureau of Archaeological Research, Division of Historical Resources,
Department of State

January 2009

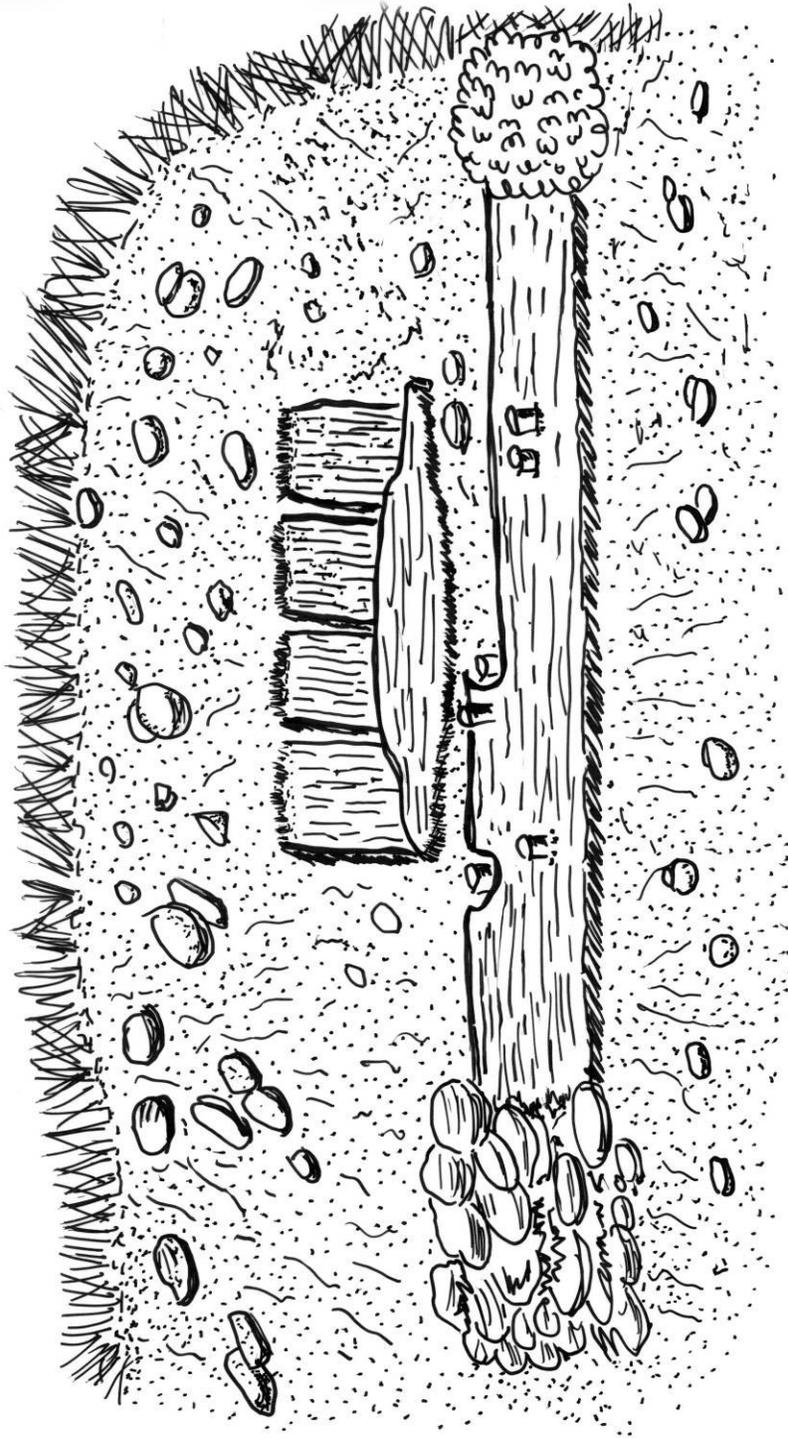
The eroded, worm-eaten wood exposed in the stern portion of the site cannot definitively be labeled the keelson; it is possible that this is deadwood between the keel and the missing sternpost. Hand fanning was used to further expose the structural remains but, without key elements such as the sternpost, rudder fittings, or additional elements of the stern assembly it is difficult to tell exactly what portion of the stern remains. For the purpose of this report the wooden remains will be referred to as the keelson.

The stern, as well as the remains of the ship, runs at 130° magnetic north. Although there was no evidence of a sternpost, the exposed section revealed four narrowing tail frames on the starboard side, set at an acute angle, bolted to the keelson. Between the keelson and tail frames are ceiling planks fastened down with alternating pairs of iron and copper-alloy bolts. Due to the deterioration, no sided-thickness or molded-heights could be determined.

View of stern looking towards the seagrass.

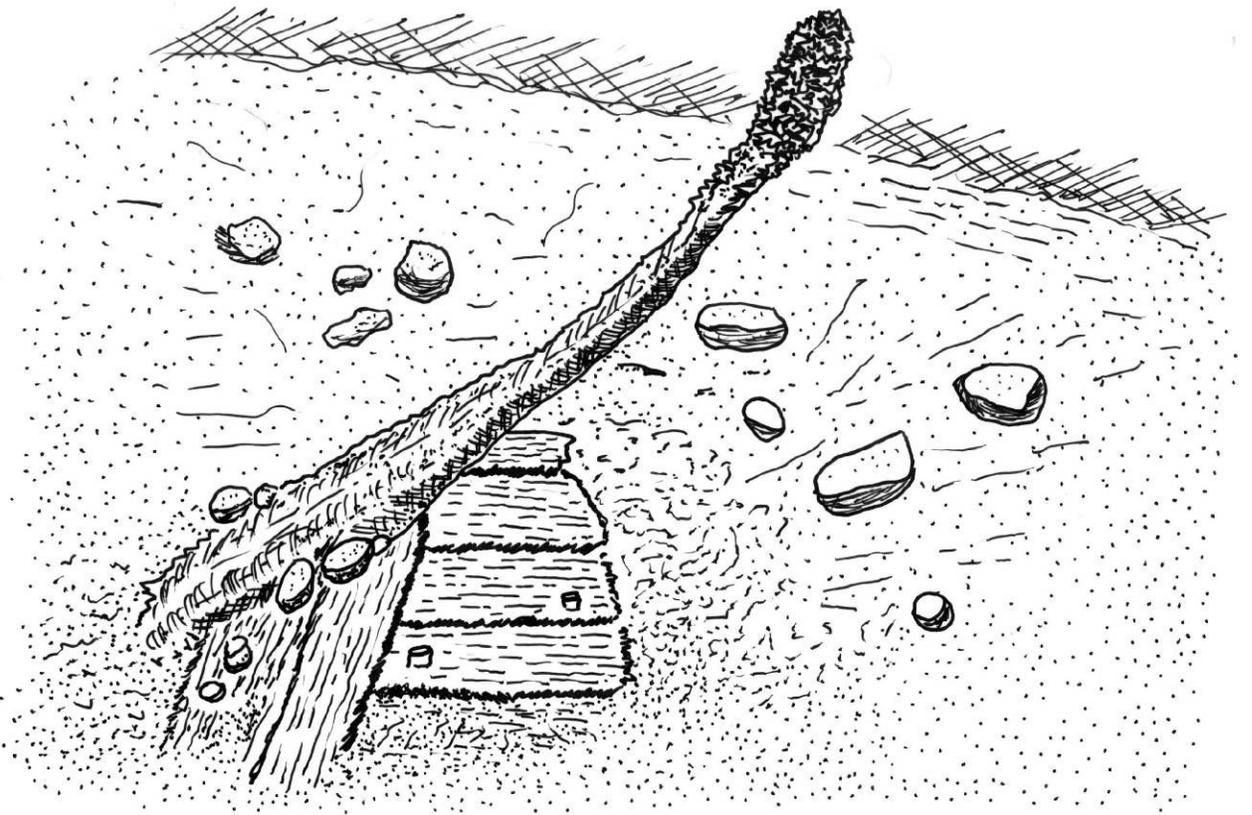
Frames 4 and 5 appear to be turtle scratching stations. Frame 4, which is located on the port side, is 78 inches in length, and has remnants of three copper-alloy fasteners spaced approximately 20 inches apart along its length. The underside of the frame has prominent, concave shapes worn into the iron as well as exposed, worn copper-alloy bolts, which show obvious signs of wear from sea turtles rubbing their dorsal carapaces against the structure to remove parasites. This activity has exposed wooden ceiling planks and frames below the iron frame and the copper-alloy pins associated with these timbers have also been worn down by turtles rubbing their plastron against the pins and

ballast stones. Frame 5, which is 72 inches in length, also shows extreme wear on its underside from turtle scratching activities.

View of Frame 4 from the bow towards the stern.

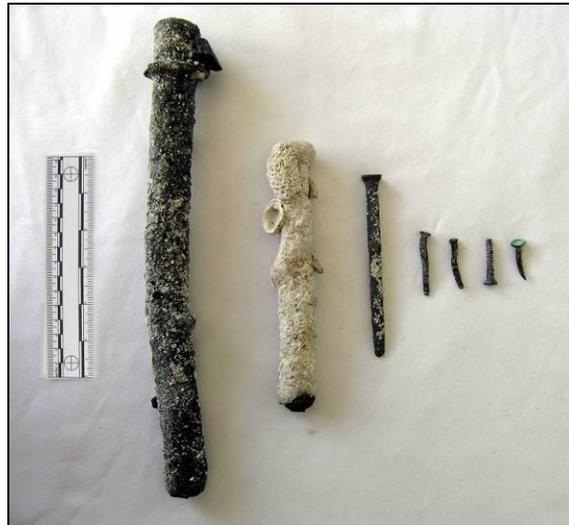
Fasteners recovered include: a copper-alloy driftbolt, an iron driftbolt, a dump bolt, two iron nails, a screw, and a copper-alloy sheathing nail.

Fasteners from left: Copper-alloy driftbolt, iron driftbolt, dump bolt, iron nail, iron nail, screw, copper-alloy sheathing nail.

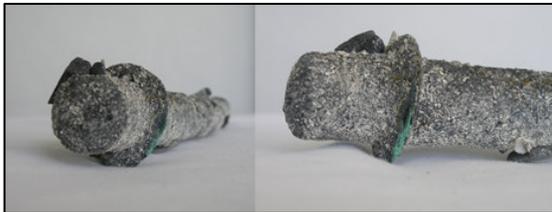
Copper-alloy Driftbolt.

Driftbolts were the largest, most durable fasteners located on the wreck site. This type of bolt would have been placed through the keelson into the keel. It would also be used as an extra-strong joint throughout the ship. The copper-alloy ring or washer is referred to as a clench ring, which helped to hold the bolt in place.

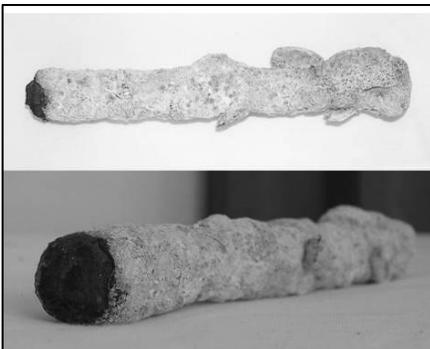
Iron Driftbolt.

Similar to the copper-alloy driftbolt, iron driftbolts were driven into an augured hole, not directly into the wood. Often these iron fasteners were hammered over clenched rings for additional support. The head and tip of the fastener were traditionally shaped by hammer.⁸

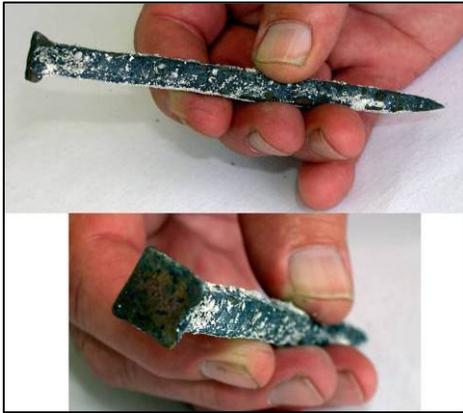
Dump bolt.

The dump bolt was driven into the wood for additional stability in conjunction with fasteners that extended through the planks into the frames. The dump bolt did not go through the full timber.

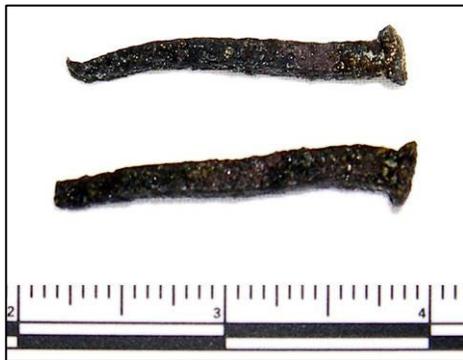
Iron nails.

Iron nails, approximately 1½ to 2 inches in length, were the most abundant nails on the ship.

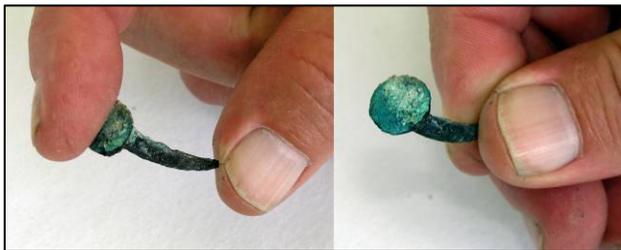
Copper-alloy Sheathing Nail.

Copper-alloy sheathing nails were used to secure the copper sheathing to the hull.
